SYSTEM BRIEF DETAIL

Report detailing the testing and classification of a precast concrete panel and mineral wool insulation external cladding system tested in accordance with the requirement as described in British Standard 8414

BS 8414-2:2020 Test Report with
Classification in Accordance with BR135

Report Reference: 103138.002

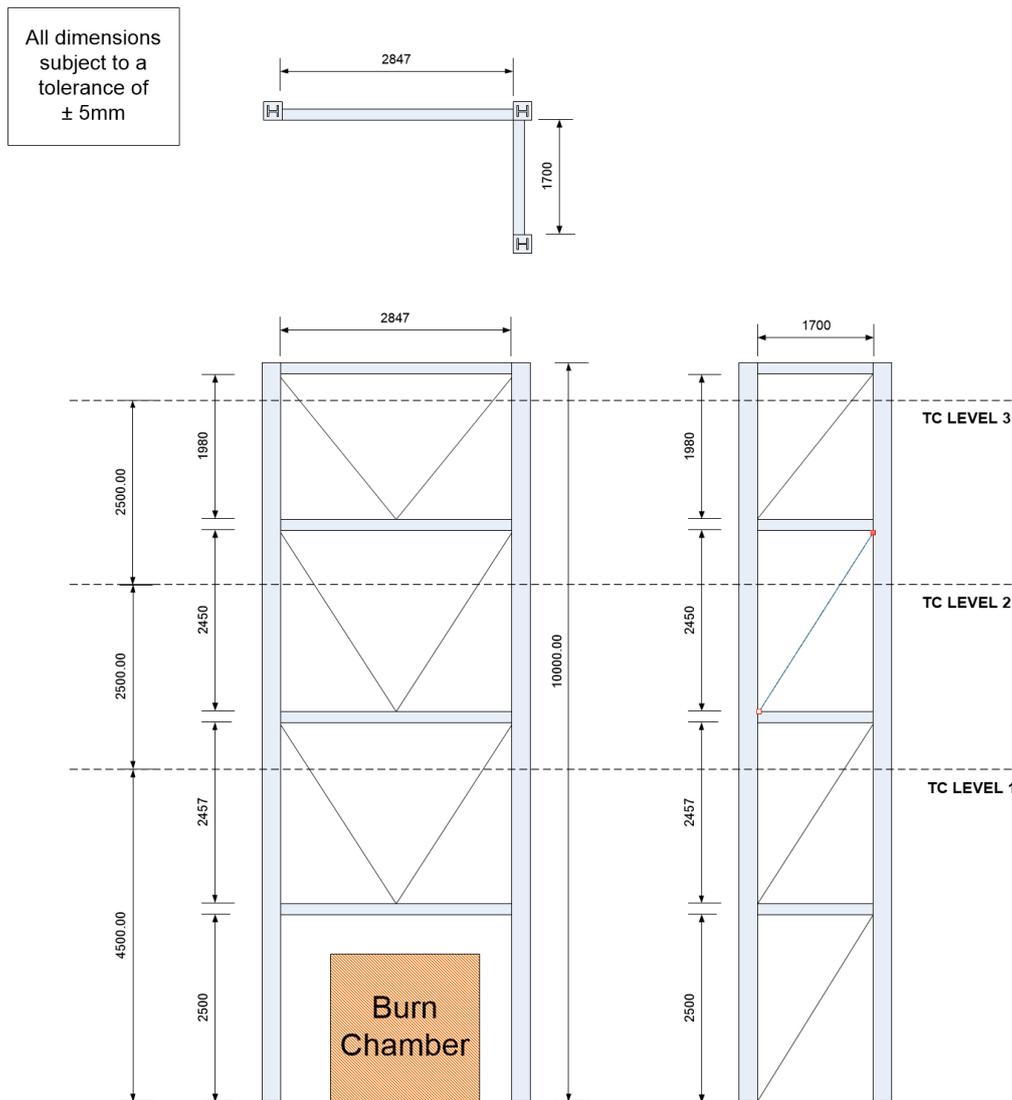
Figure 1 - Test apparatus dimensions [As specified by test Standard Figure B.1]

The apparatus is defined in the Test Standard [1] and consists of a steel frame structure that forms a vertical main test wall and a vertical return wall at a 90° angle at one end of the main test wall as shown in Figure 1. The main wall includes the combustion chamber.

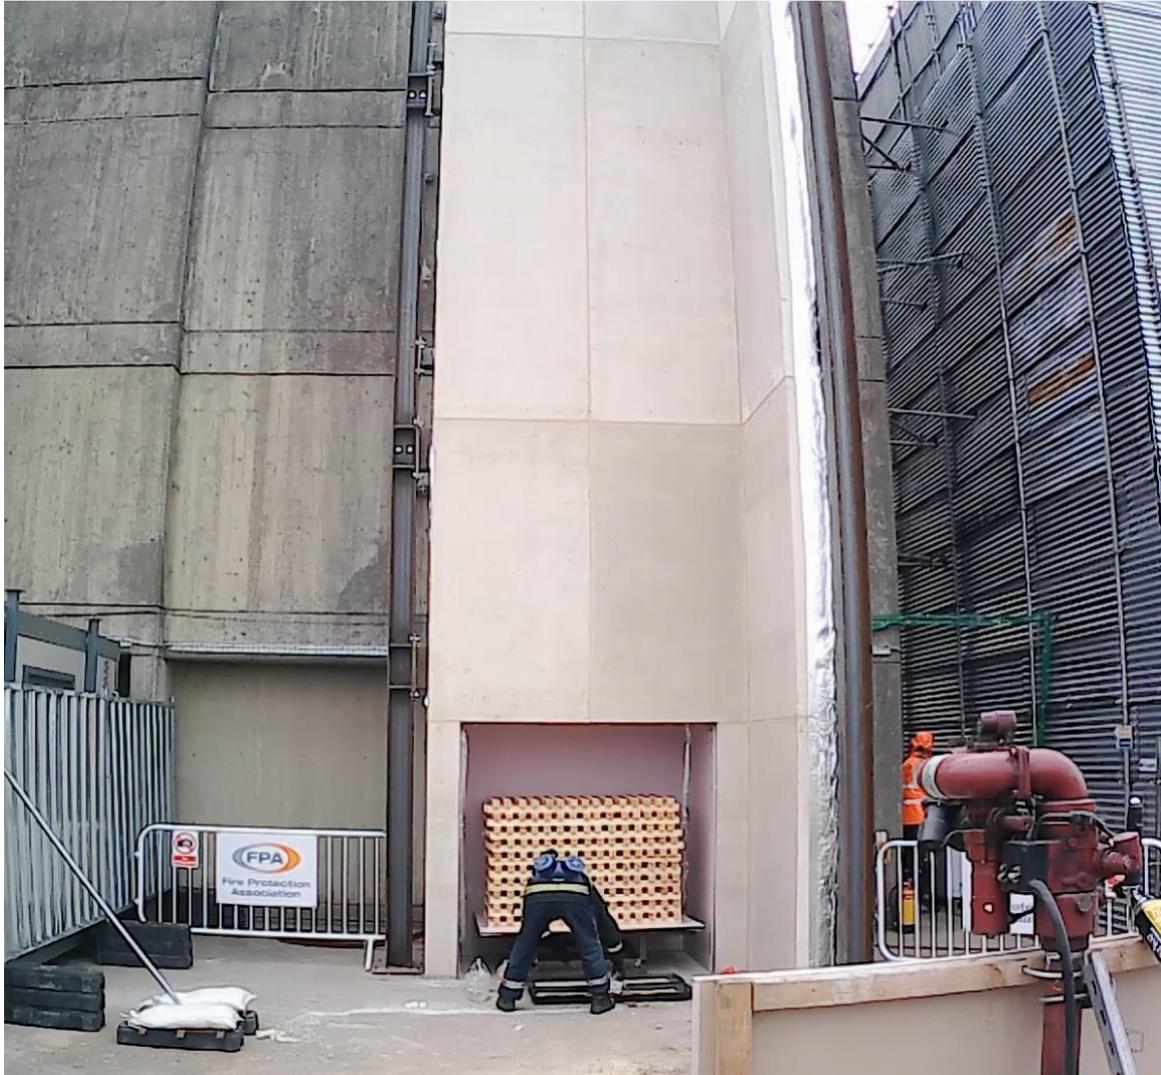
Figure 2 – Completed test specimen prior to test start

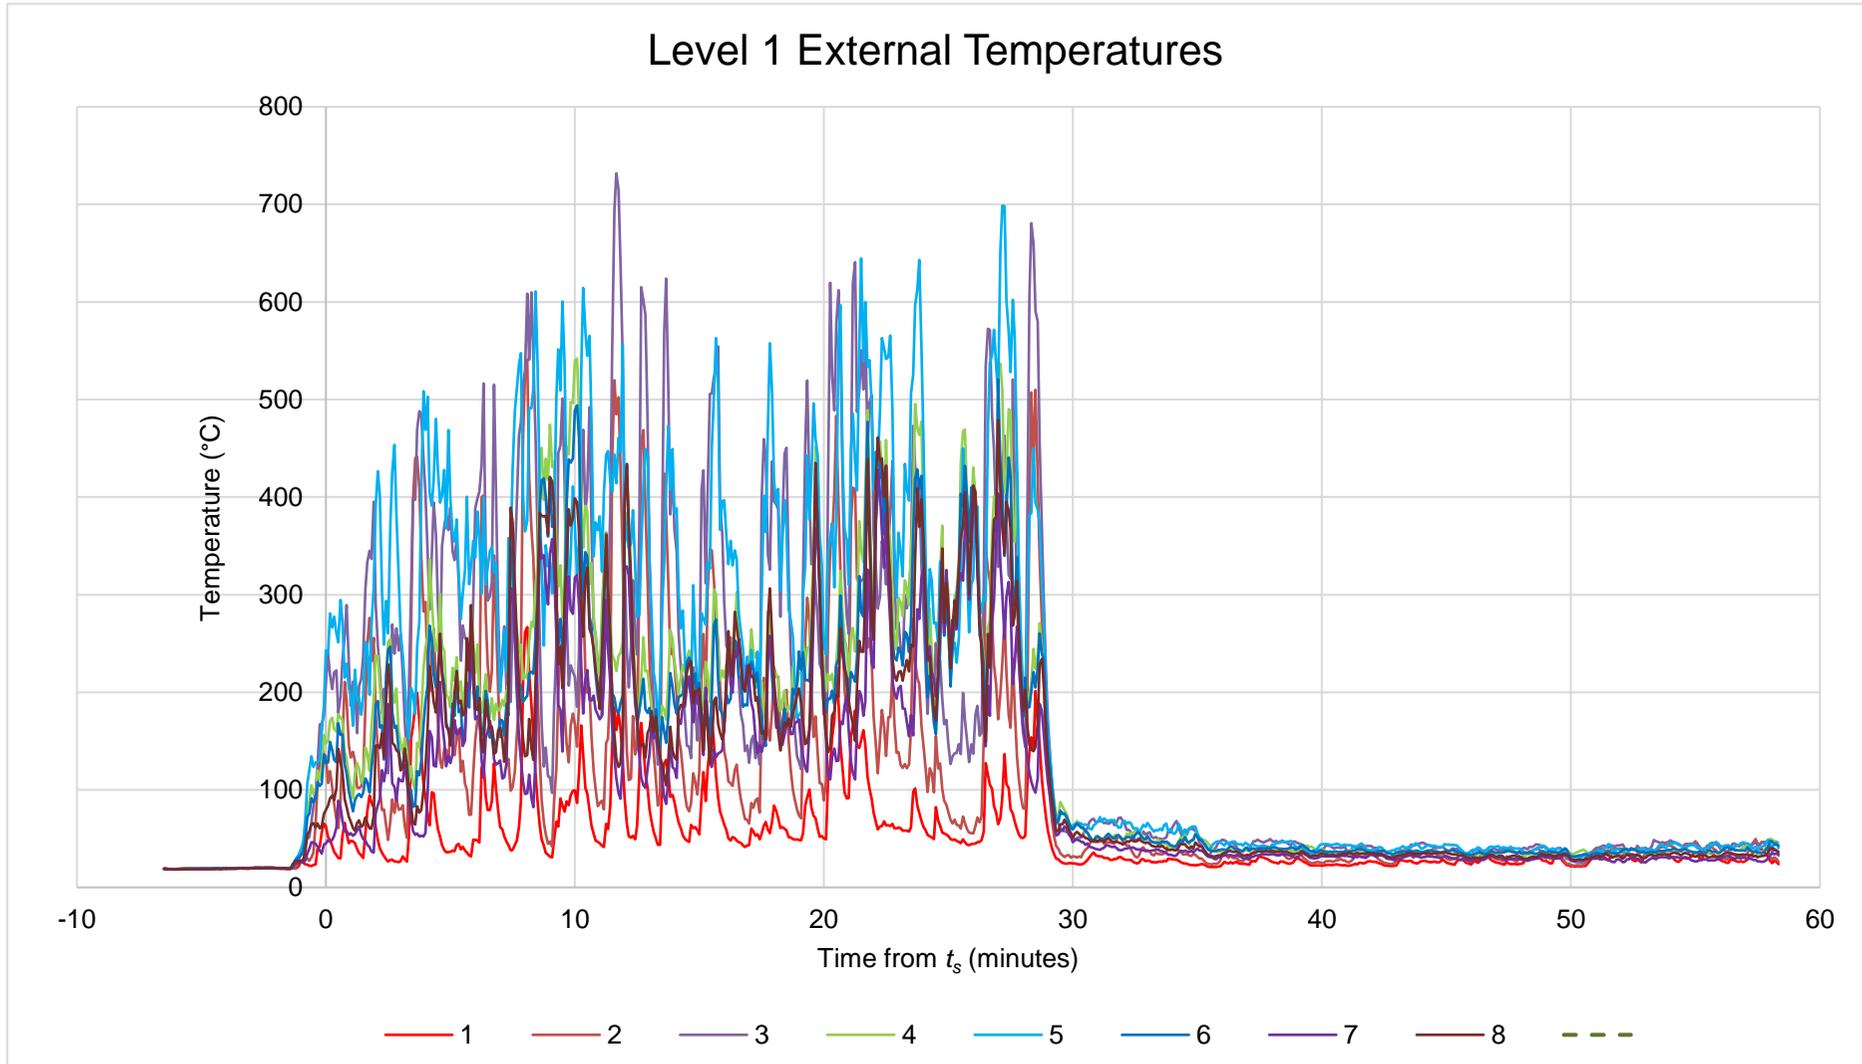
Figure 3 – External temperatures at level 1

Test results for the evaluation of fire spread and start time are detailed in the tables below. Temperature profiles recorded during the test are shown in Figure 3 to Figure 4.

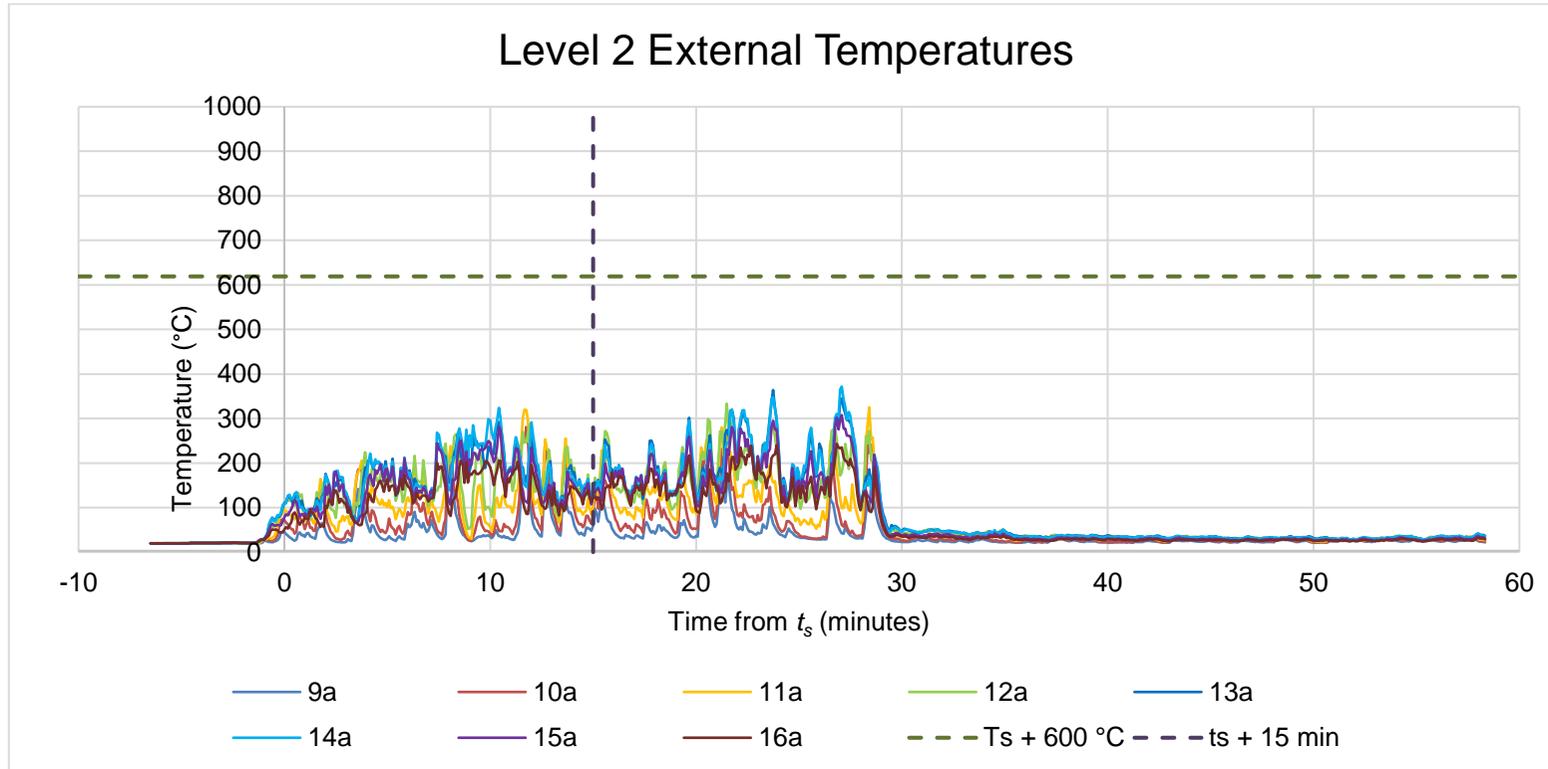
Figure 4 External temperatures at level 2

External fire spread								
Level 2, external thermocouples								
Thermocouple ID	9a	10a	11a	12a	13a	14a	15a	16a
Peak temperature (°C)	199.5	281.0	319.9	285.7	292.4	324.0	281.9	205.6
Internal fire spread								
Level 2, thermocouples in façade								
Thermocouple ID	9b	10b	11b	12b	13b	14b	15b	16b
Peak temperature (°C)	22.6	20.1	19.3	22.1	34.7	43.0	27.0	20.7
Level 2, thermocouples in cavity								
Thermocouple ID	9c	10c	11c	12c	13c	14c	15c	16c
Peak temperature (°C)	17.2	17.4	18.0	18.0	18.5	20.9	20.3	19.9
Level 2, thermocouples in insulation								
Thermocouple ID	9d	10d	11d	12d	13d	14d	15d	16d
Peak temperature (°C)	29.8	23.3	22.6	24.5	23.0	33.7	39.4	44.2

6.1.1 External fire spread: The temperature recorded at any external thermocouple at level 2 should not exceed T_s by more than 600°C for a period of at least 30 seconds, within 15 minutes of start time t_s .

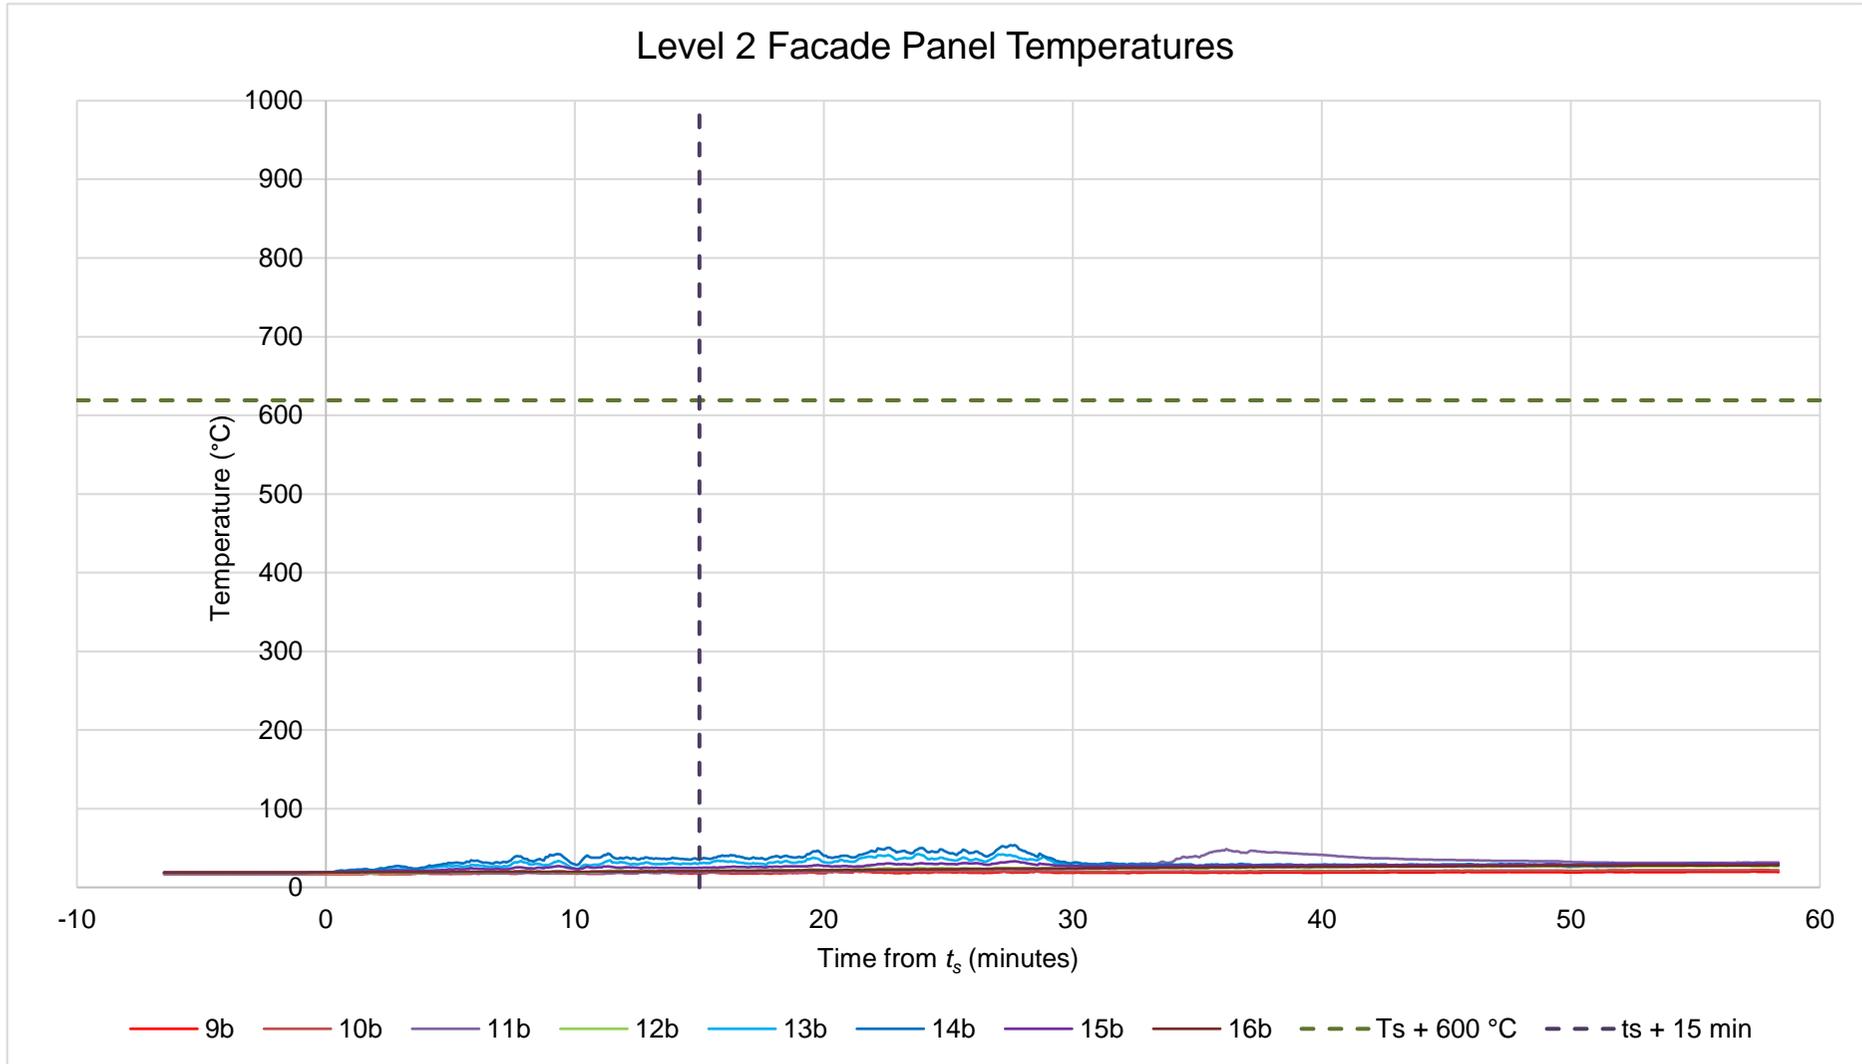
Figure 5 – Façade internal temperatures at level 2

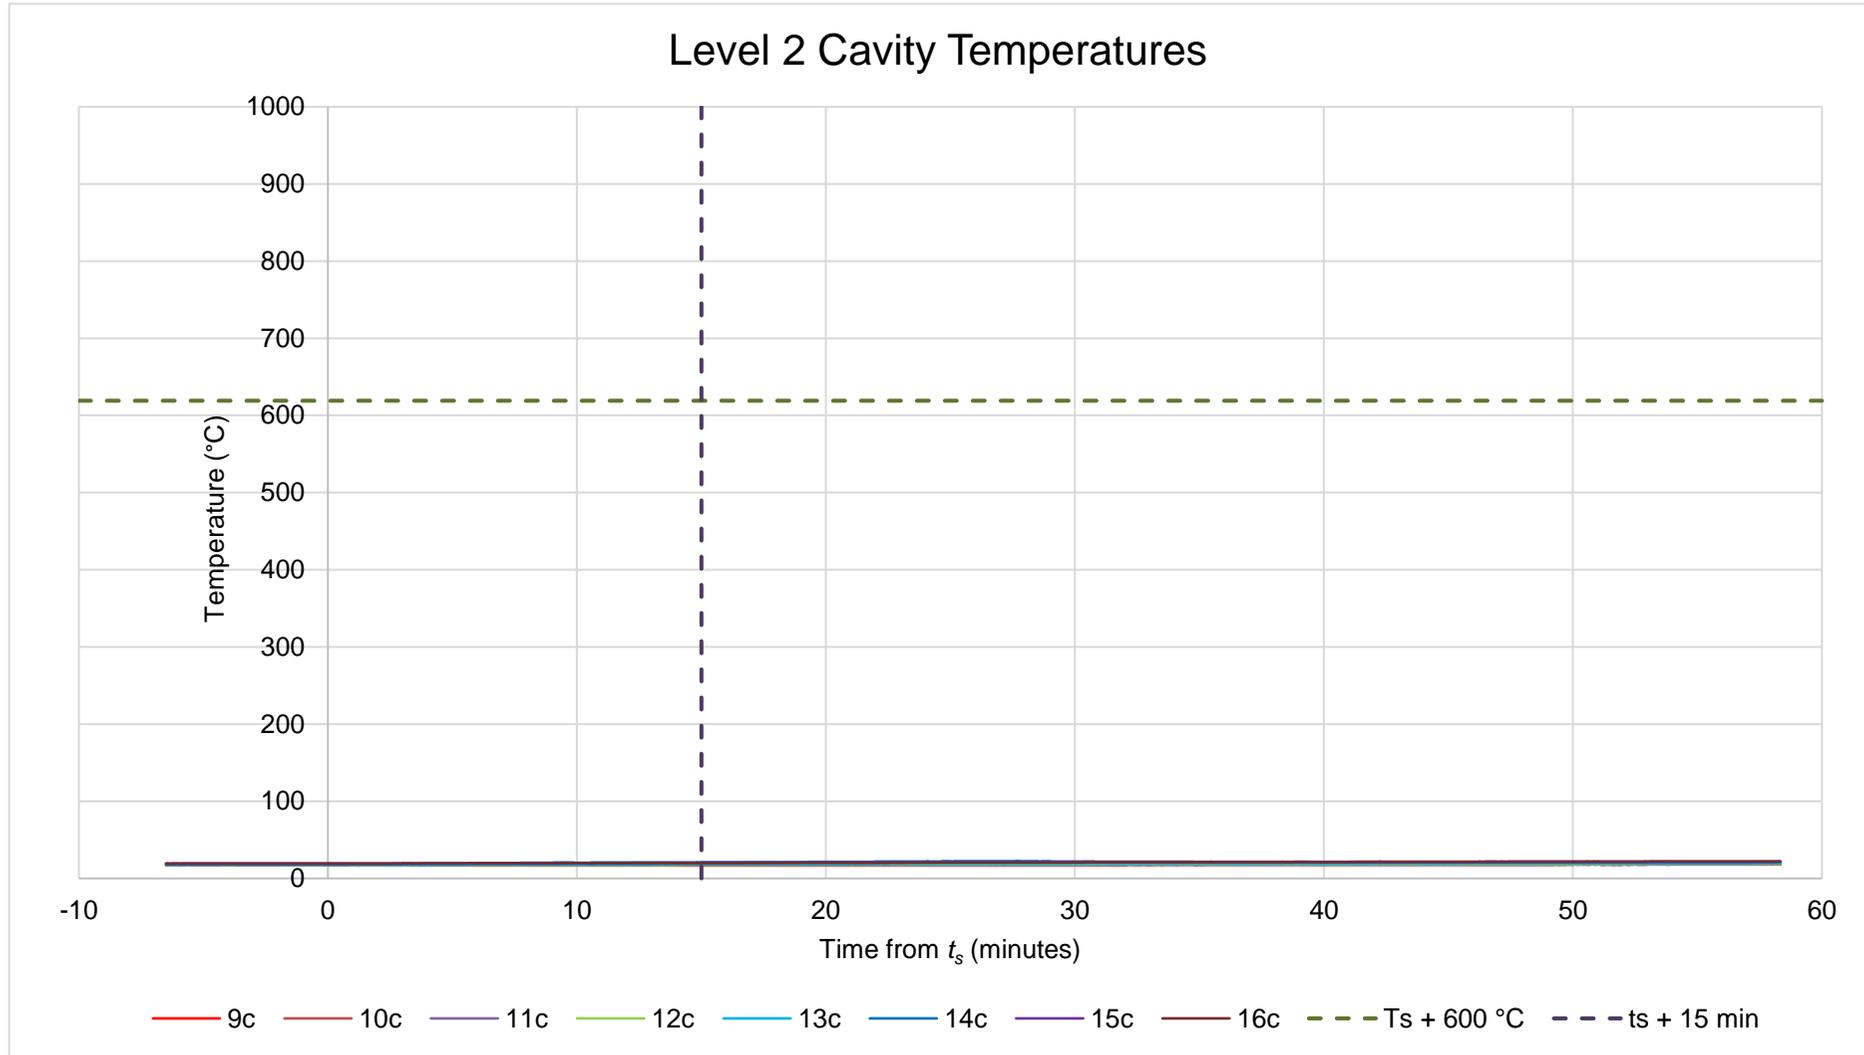
Figure 6 – Cavity internal temperatures at level 2

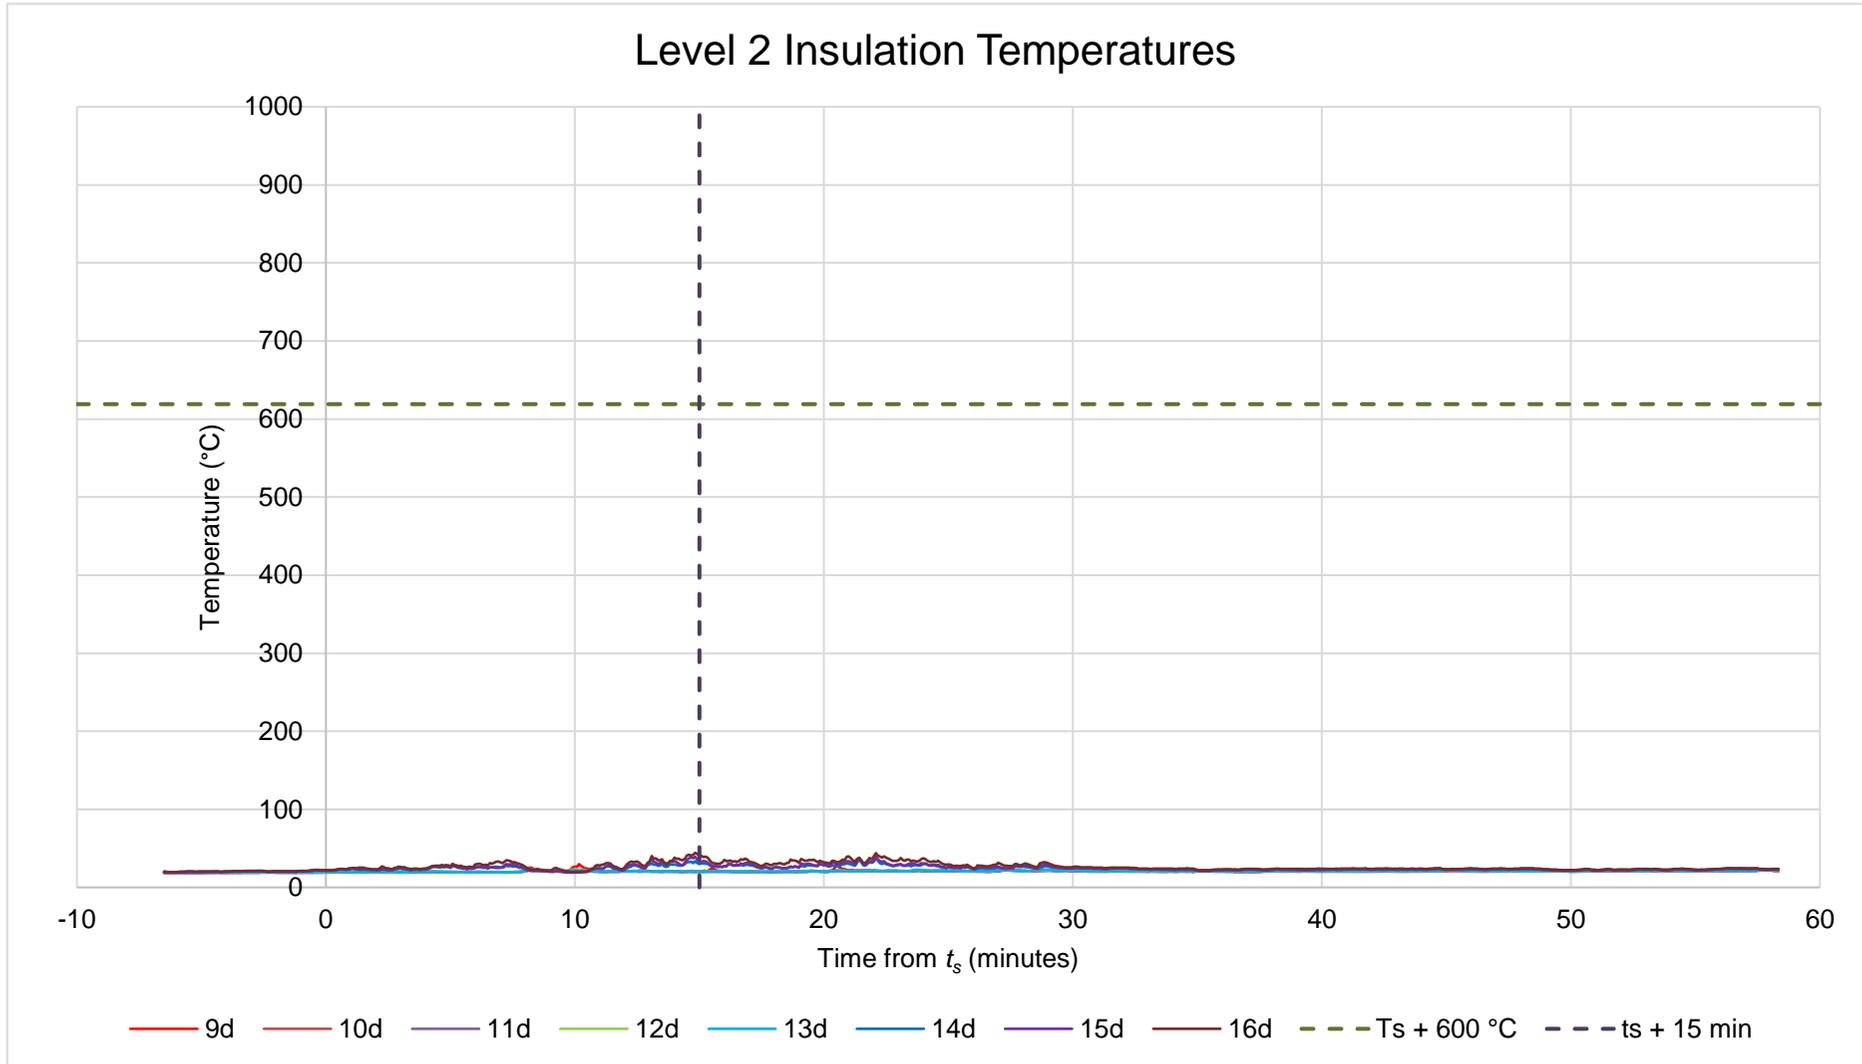
Figure 7 – Insulation internal temperatures at level 2

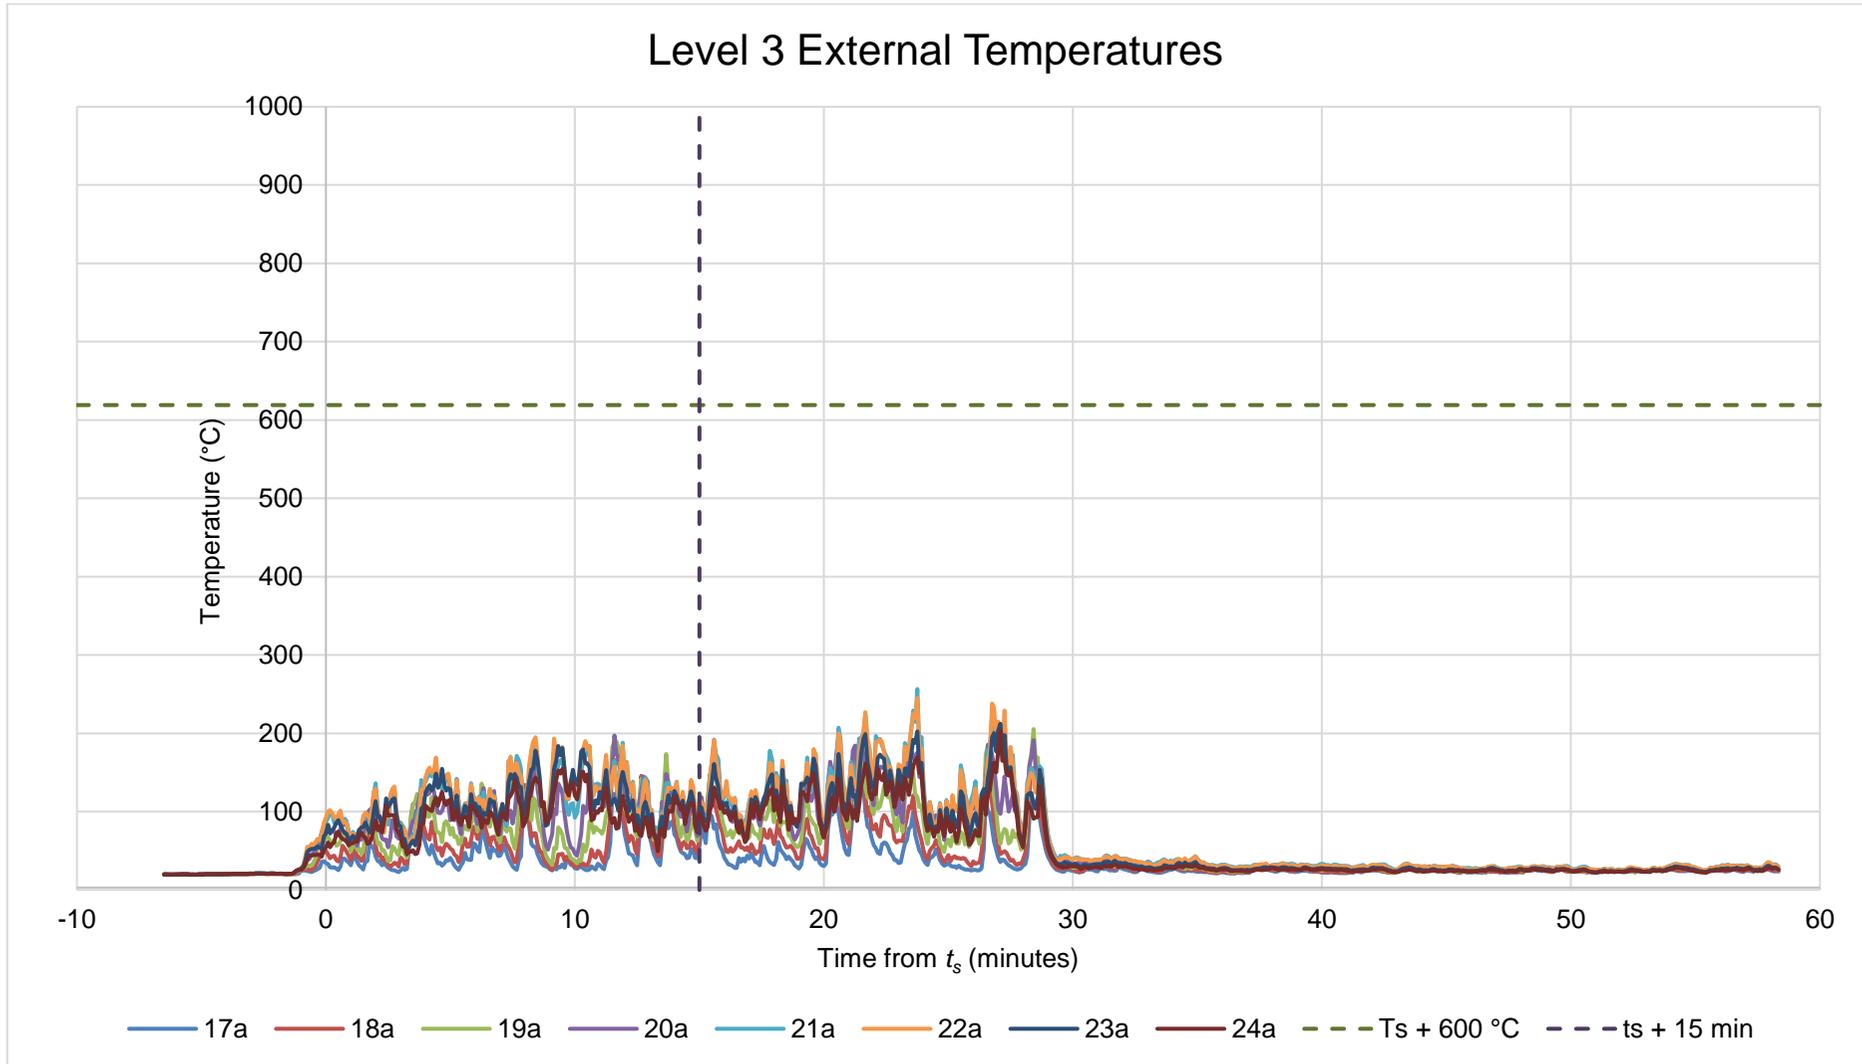
Figure 8 – External temperatures at level 3

External fire spread								
Level 3, external thermocouples								
Thermocouple ID	17a	18a	19a	20a	21a	22a	23a	24a
Peak temperature (°C)	141.3	166.1	189.8	197.2	187.7	194.7	183.9	154.6
Internal fire spread								
Level 3, thermocouples in façade								
Thermocouple ID	17b	18b	19b	20b	21b	22b	23b	24b
Peak temperature (°C)	21.3	20.3	18.3	20.1	19.1	19.8	19.0	20.5
Level 3, thermocouples in cavity								
Thermocouple ID	17c	18c	19c	20c	21c	22c	23c	24c
Peak temperature (°C)	18.1	18.4	18.4	18.2	-	24.5	19.5	18.9
Level 3, thermocouples in insulation								
Thermocouple ID	17d	18d	19d	20d	21d	22d	23d	24d
Peak temperature (°C)	24.0	24.4	25.4	21.6	20.0	38.6	40.4	49.7

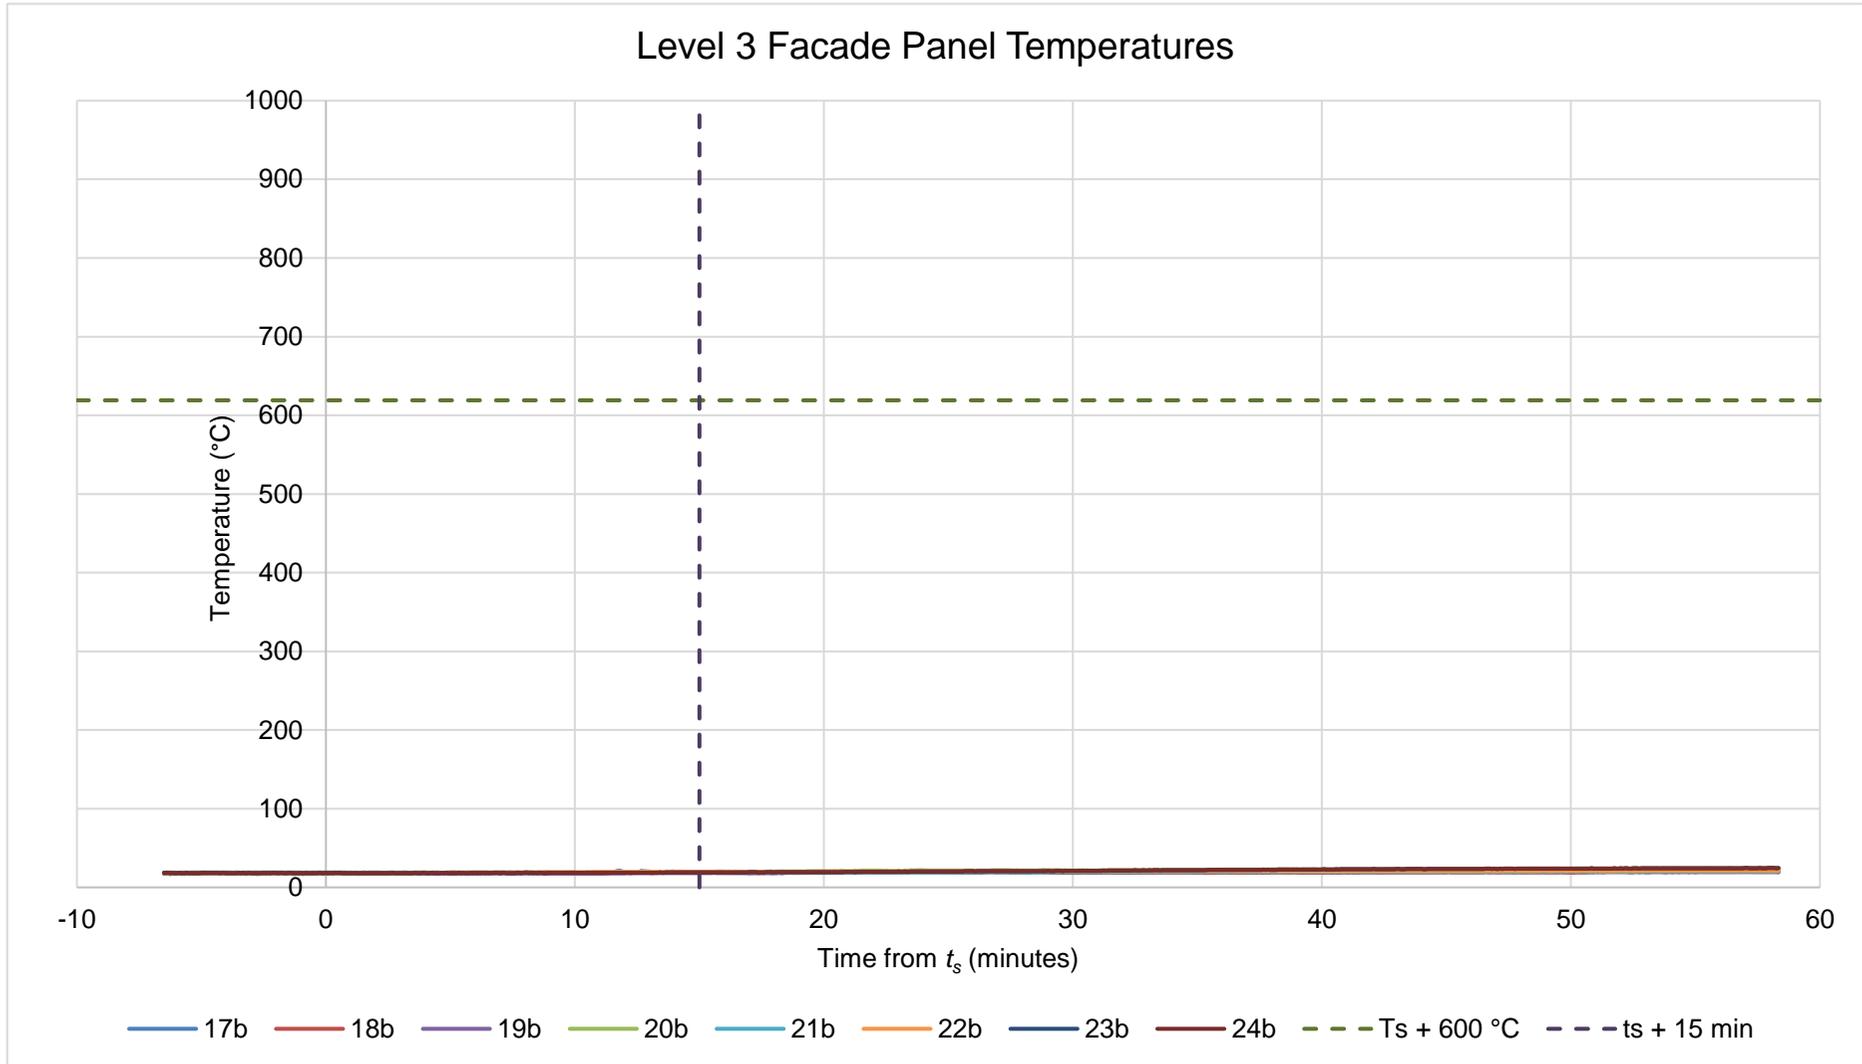
Figure 9 – Façade internal temperatures at level 3

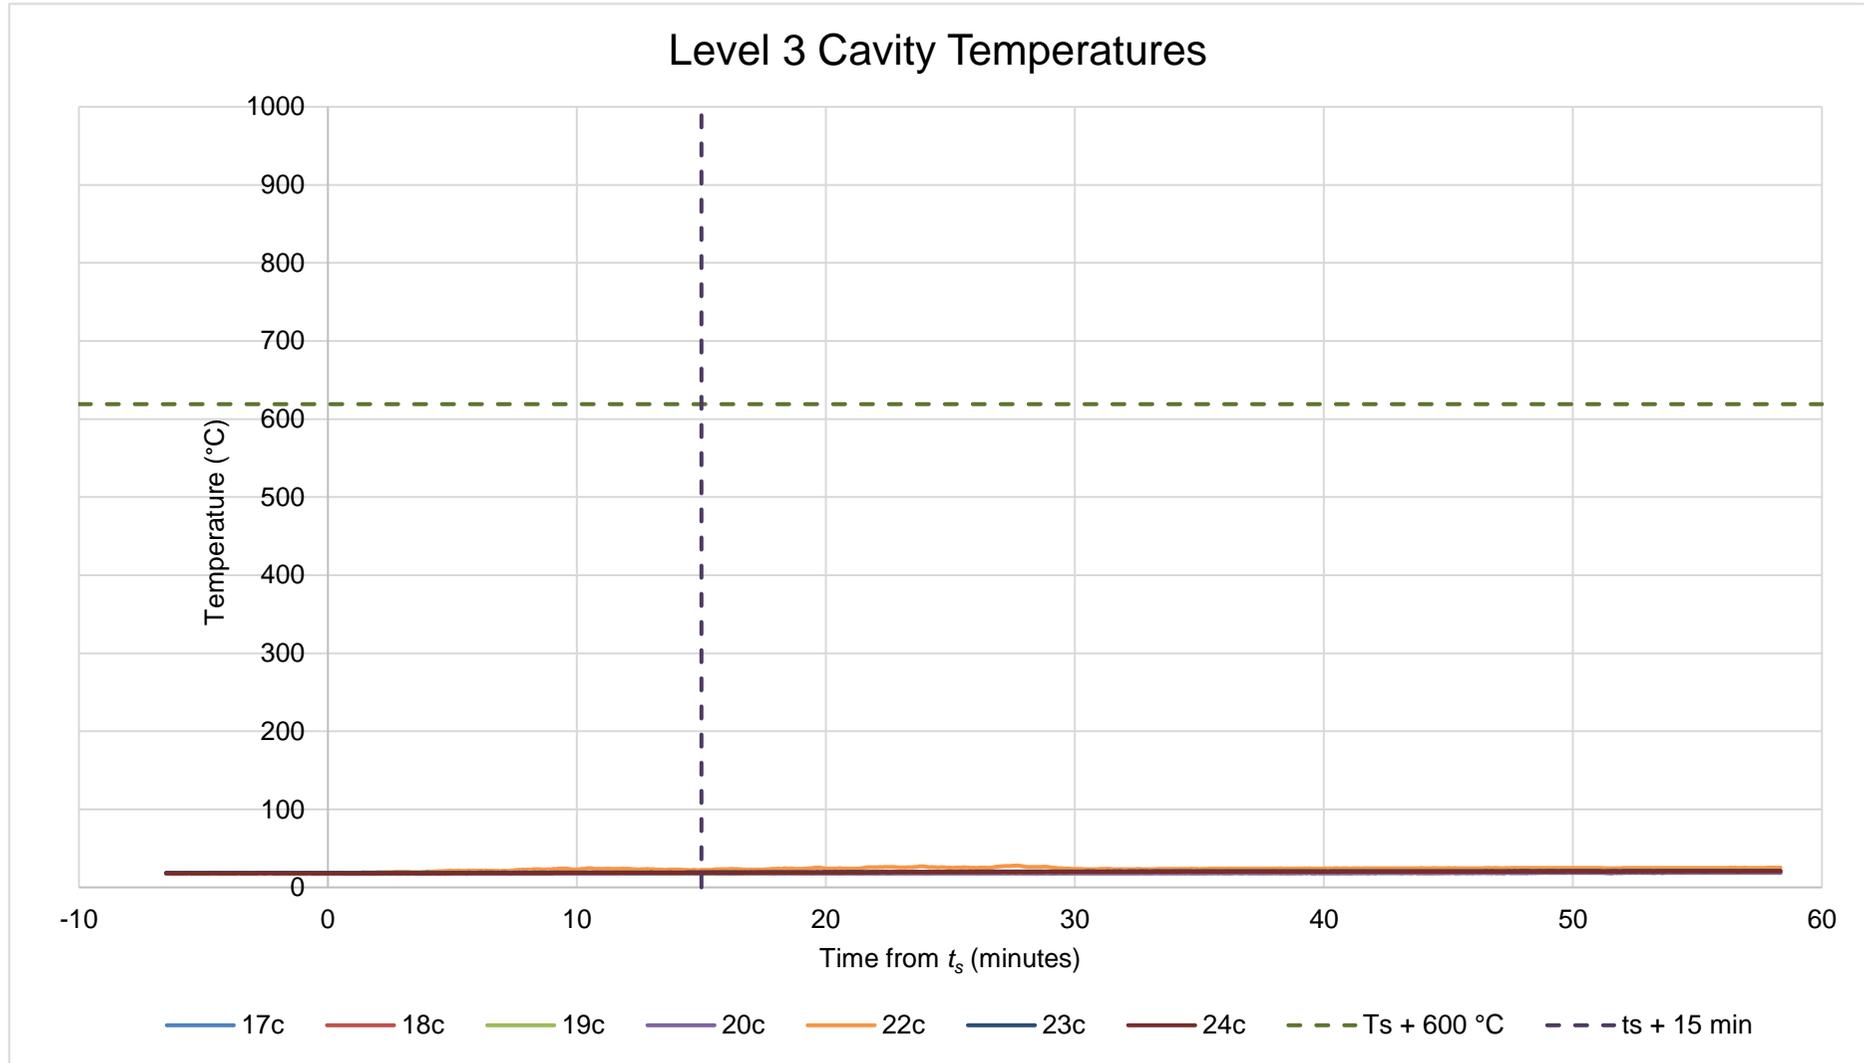
Figure 10 – Cavity internal temperatures at level 3

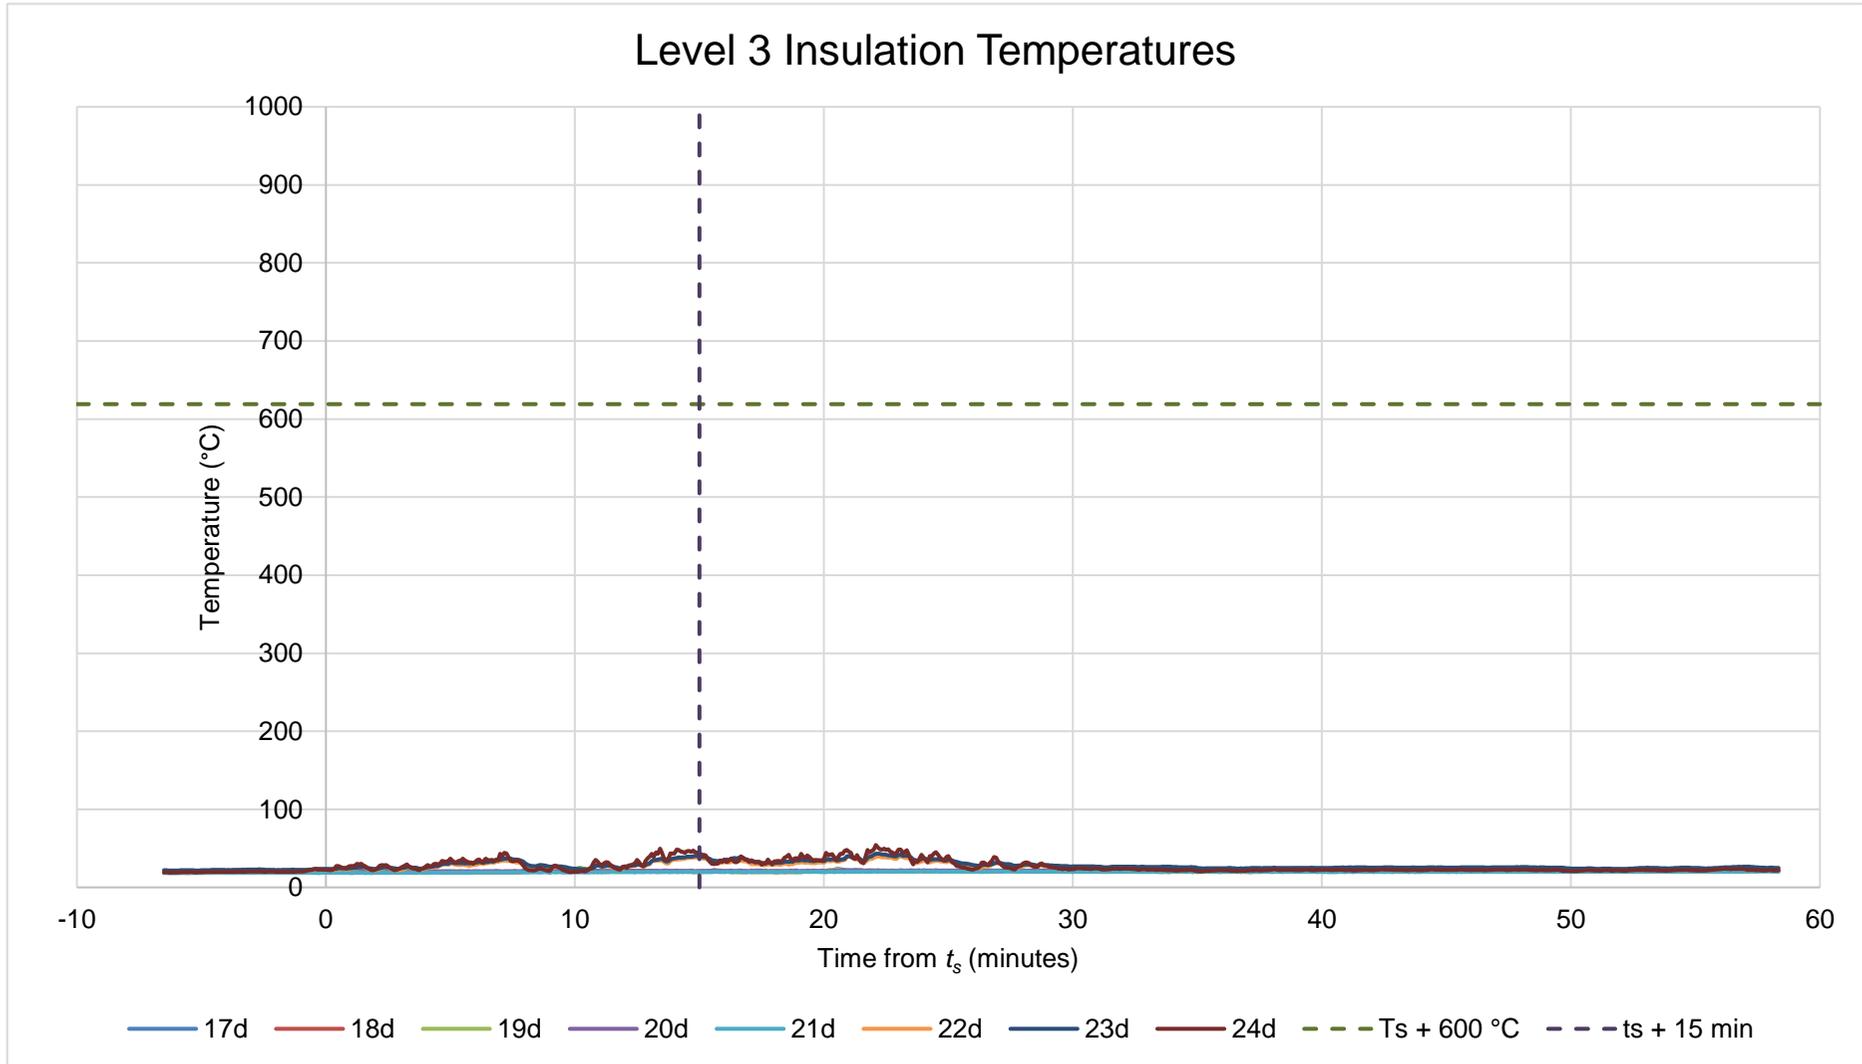
Figure 41 – Insulation internal temperatures at level 3

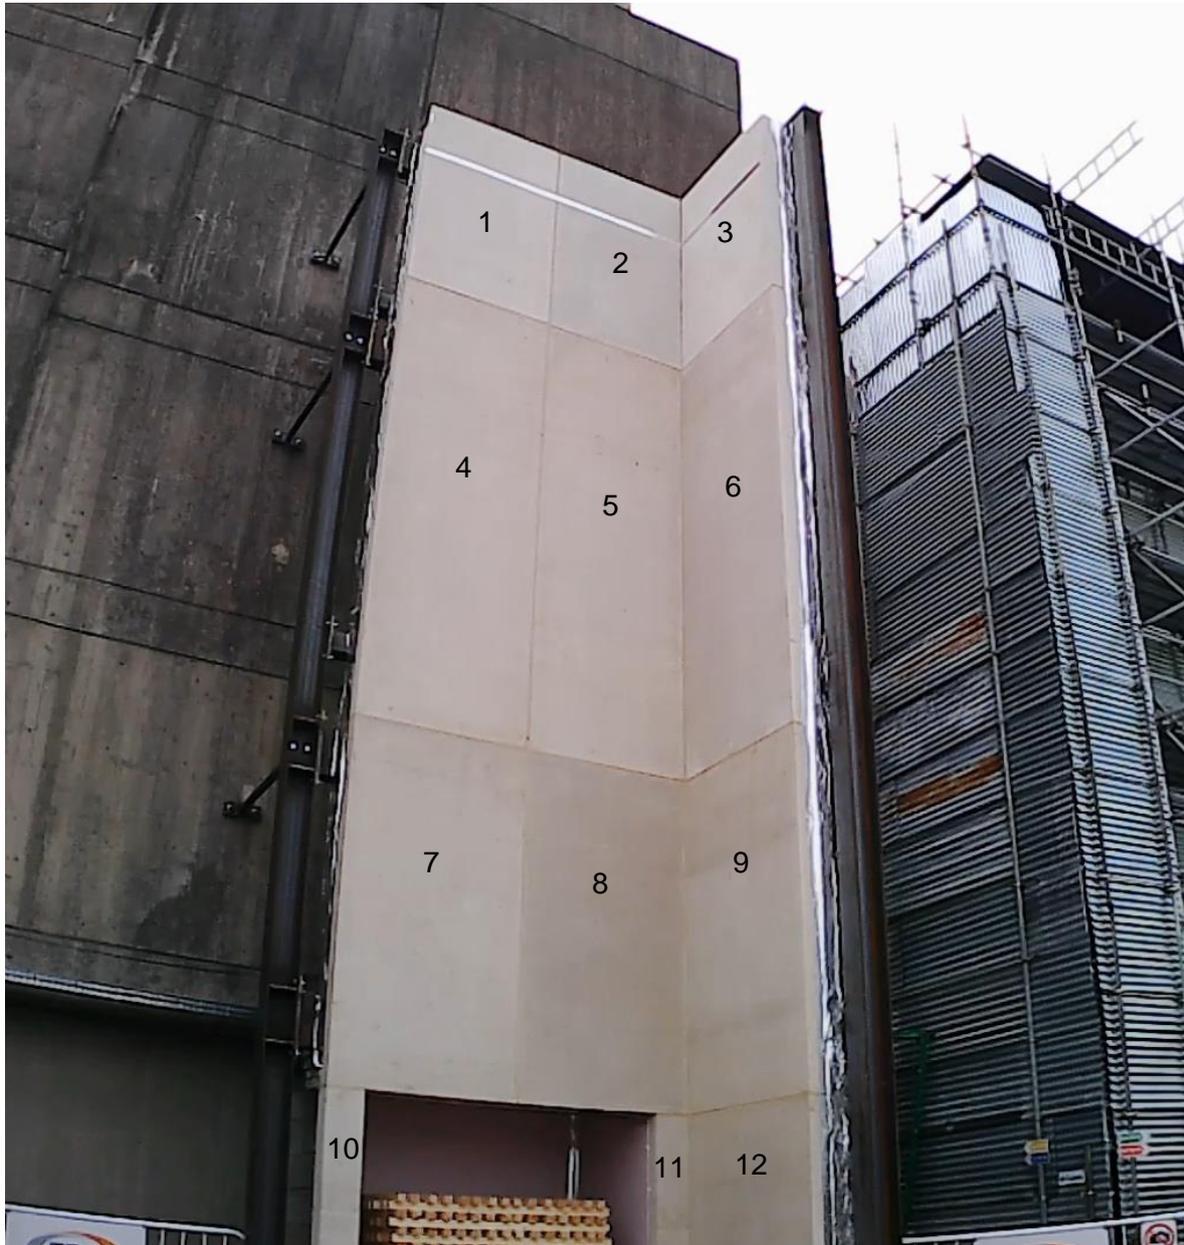
Figure 52 – Façade Panel Numbering

For identification purposes, the façade panels were numbered as follows:
