SYSTEM BRIEF DETAIL

Report detailing the testing and classification of a precast concrete panel and mineral wool insulation external cladding system tested in accordance with the requirement as described in British Standard 8414

BS 8414-2:2020 Test Report with
Classification in Accordance with BR135

Report Reference: 103138.002

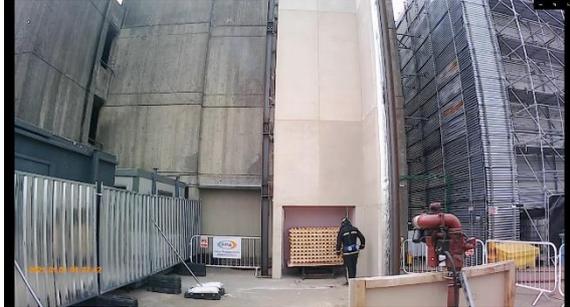
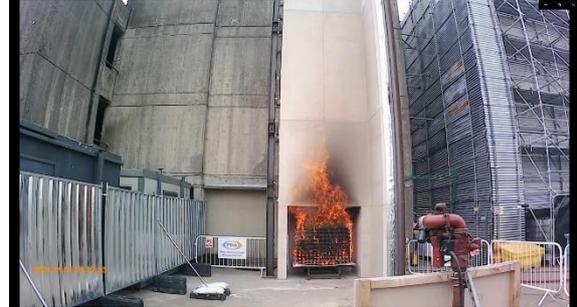
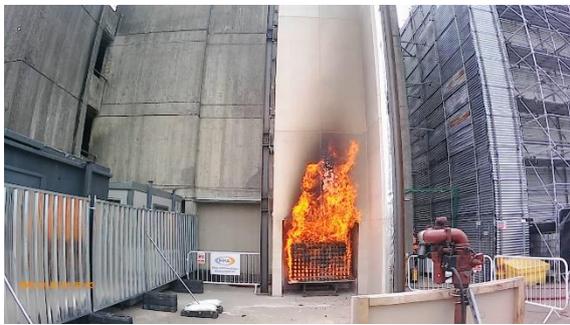
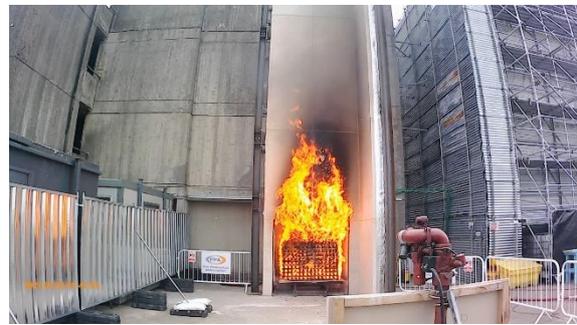
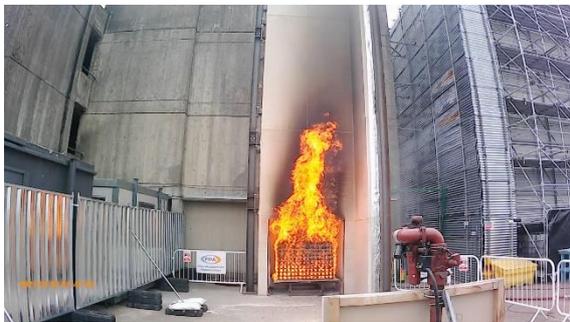
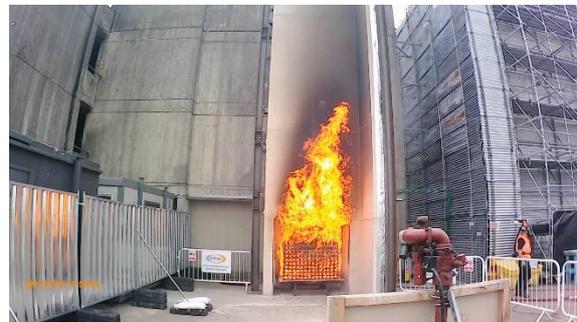
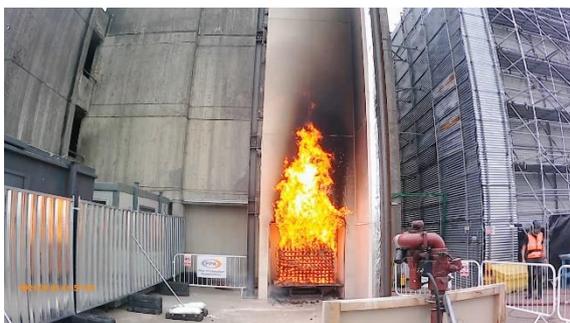
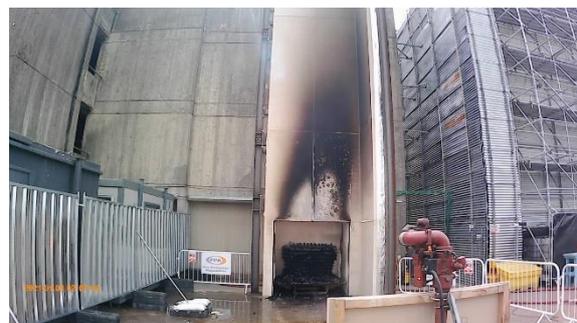
The test was filmed using the FPA's SANCE CCTV system in the test chamber. The following images (Figure 6 to Figure) are screenshots taken directly from the footage recorded of the test.

Time from ignition (mins:secs)	Description
-08:00	Datalogger and video recording started
-07:00	Stopwatch started
-07:00	Fibreboard sticks inserted into crib
00:00	Ignition of crib
02:15	Crib fully involved
02:40	Discolouration bottom of panels 8 & 9
05:15	Small chips appear in 8 (<5 cm ²)
06:00	More small chips appear in 8 (<5 cm ²)
06:40	Small chips appear in 8 (~5 cm ²)
07:30	Constant sustained spalling
08:00	Large chip shower (panel 8)
09:19	>5cm ² spalling
11:05	More >5cm ² spalling
15:15	Flaming in centre joint between 7 & 8
16:40	No spalling for approximately 3 minutes
27:30	Wing wall joint between 9 & 12 flaming
30:00	Crib extinguished. No further flaming observed
60:00	Test Complete

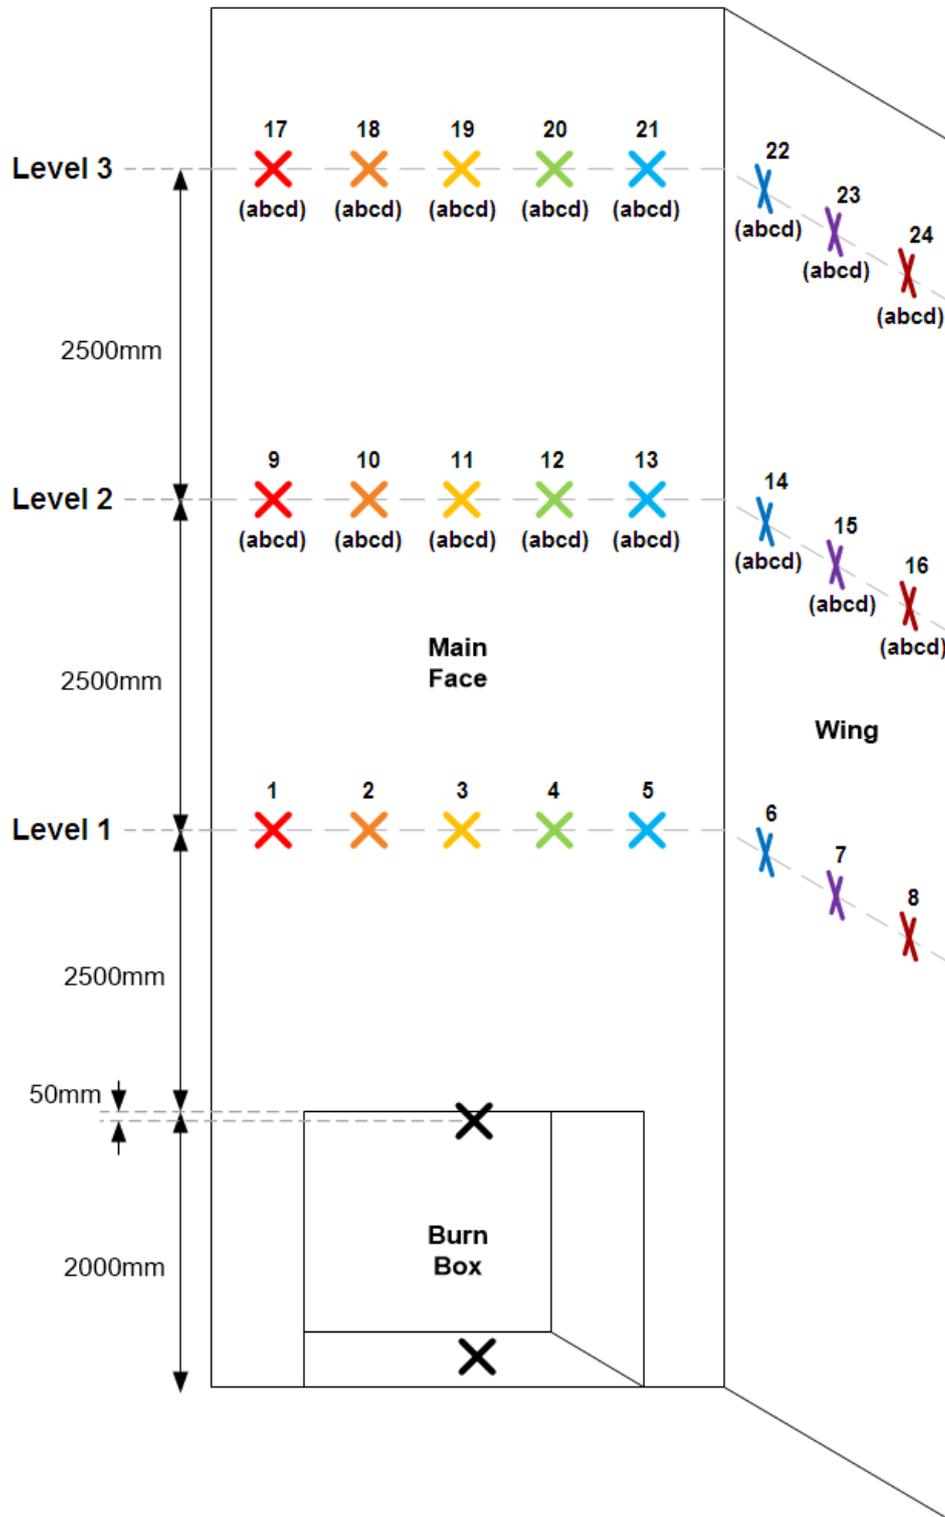
Figure 121 – Thermocouple locations on the test wall

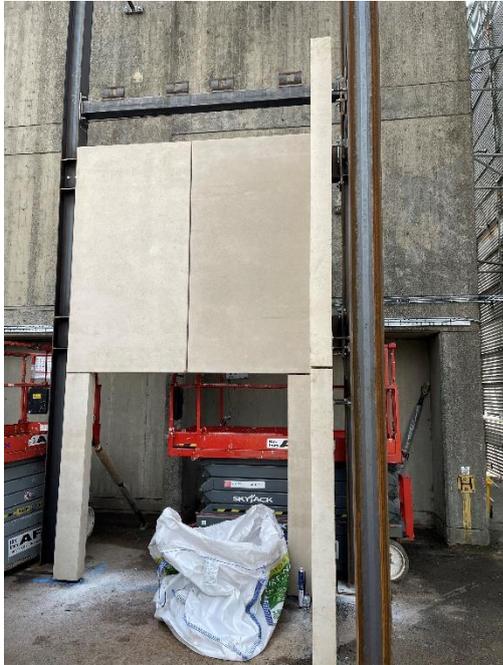
Figure 22 Detail of precast panel attached to frame

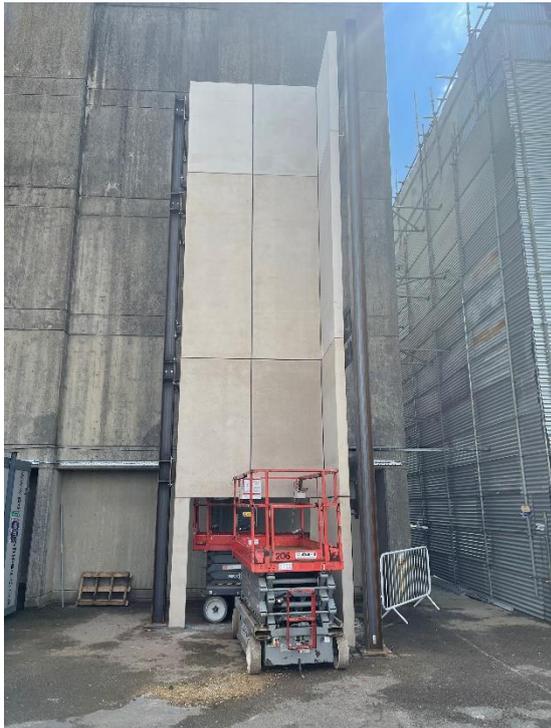
Figure 23 Façade completed

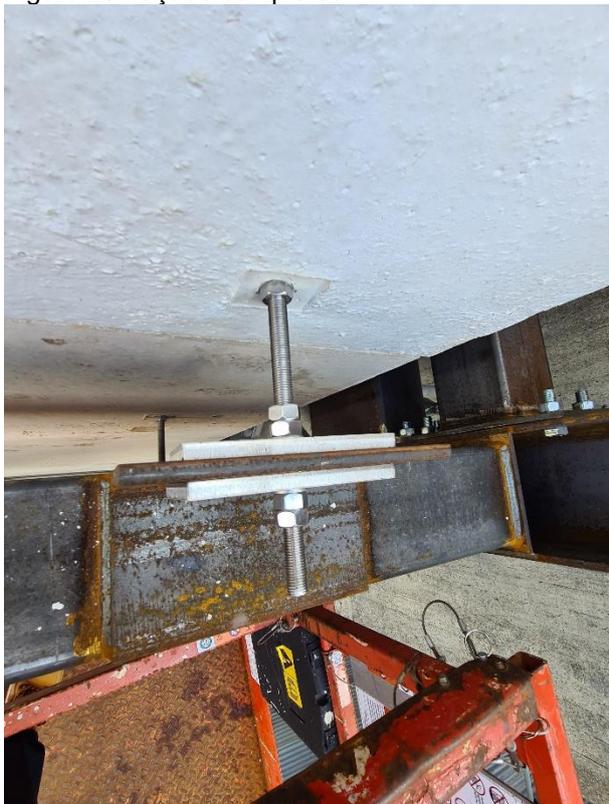
Figure 24 Detail of bracket holding panel to frame

- Vertical load from the panels applied into the structure using a combination of independent support and stacked to ground. Both being restrained back to structure to resist lateral loads.
- All fixings back to primary structure being of carbon steel or stainless steel, to EC3 design

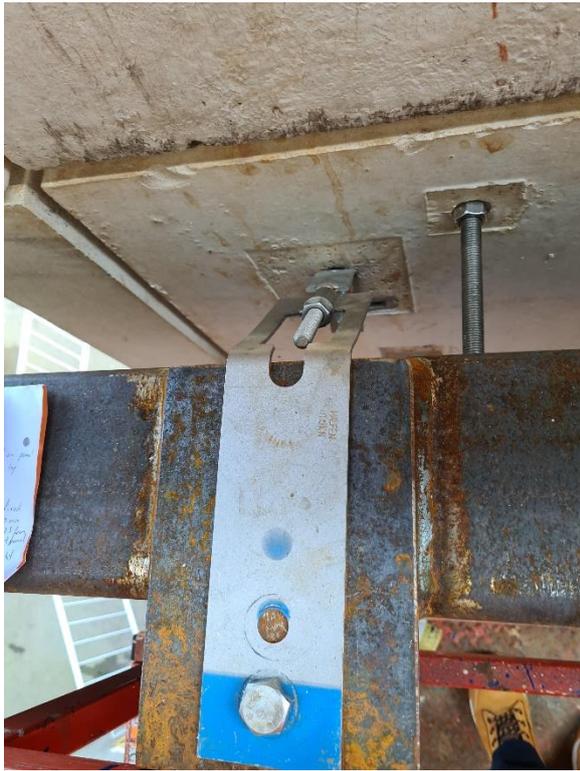
Figure 25 Detail of bracket holding panel to frame

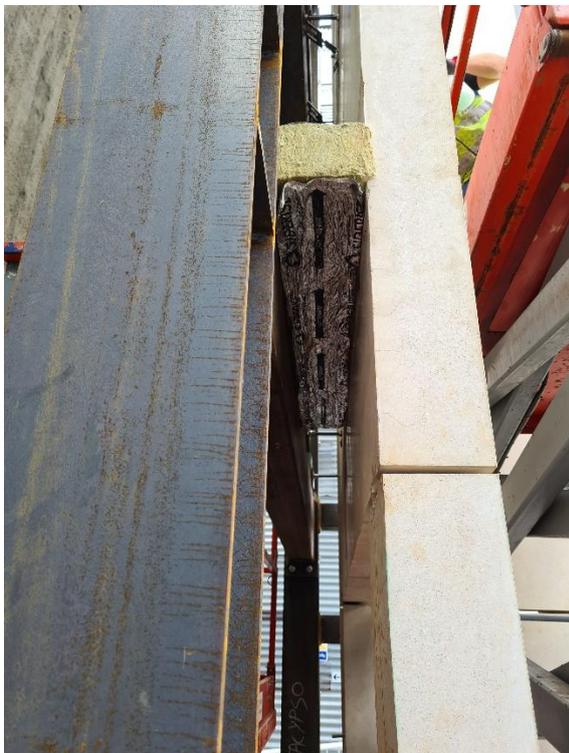
Figure 26 Horizontal cavity barrier installed

- Siderise CW-FS 120

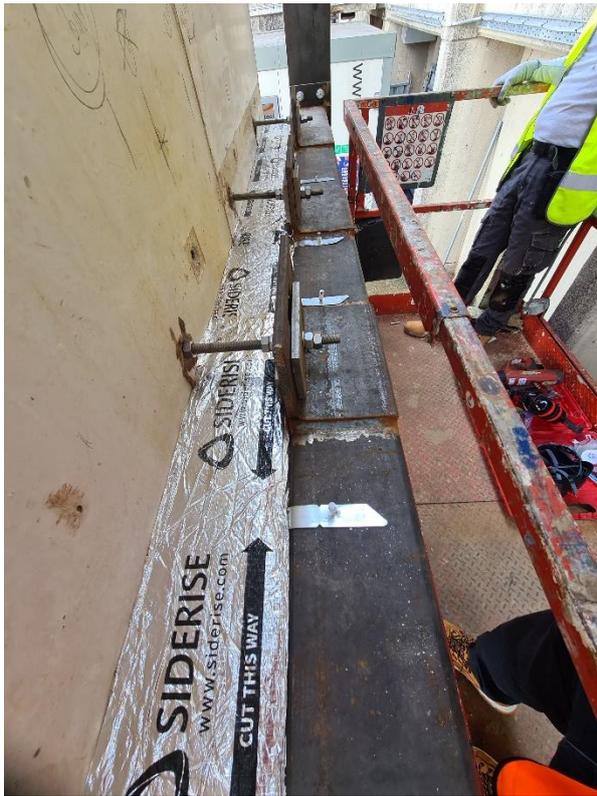
Figure 27 More detail of horizontal cavity barrier.

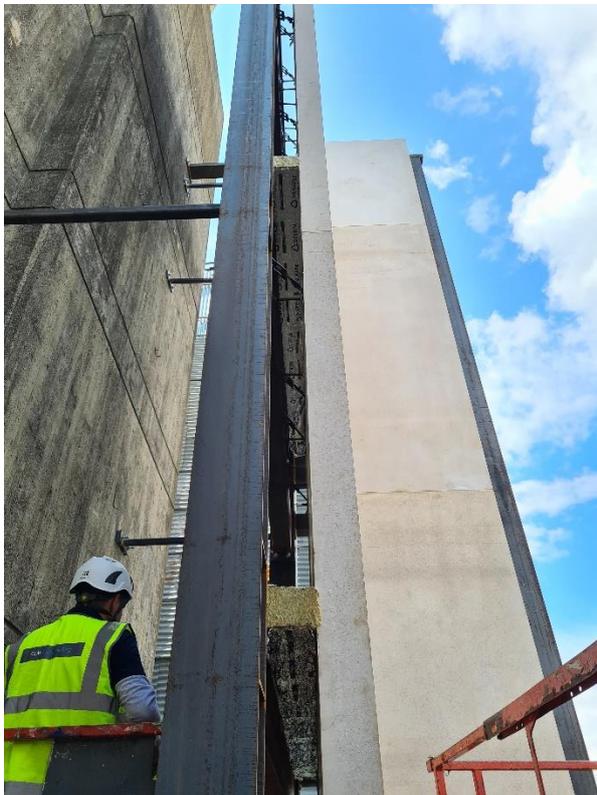
Figure 28 Second horizontal cavity barrier installed.

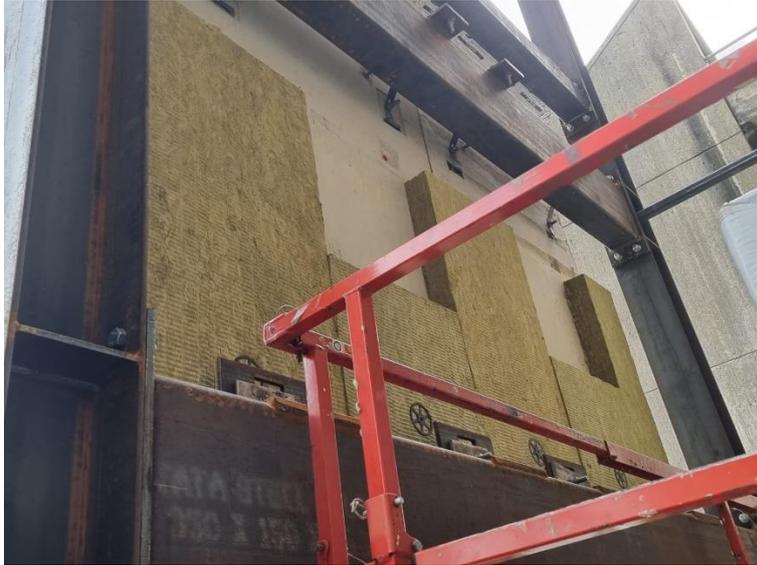
Figure 29 Rear of panel showing beginning of insulation install

- 150mm thick RW3 Rockwool – Foil face mineral wool insulation - VCL. A1 classified (to BS EN 13501-1)

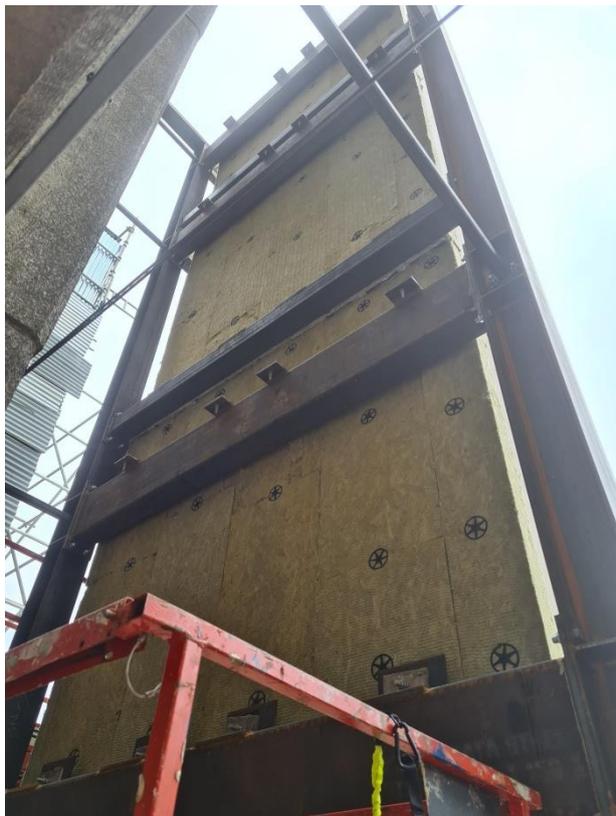
Figure 30 Rear of panel showing insulation completed

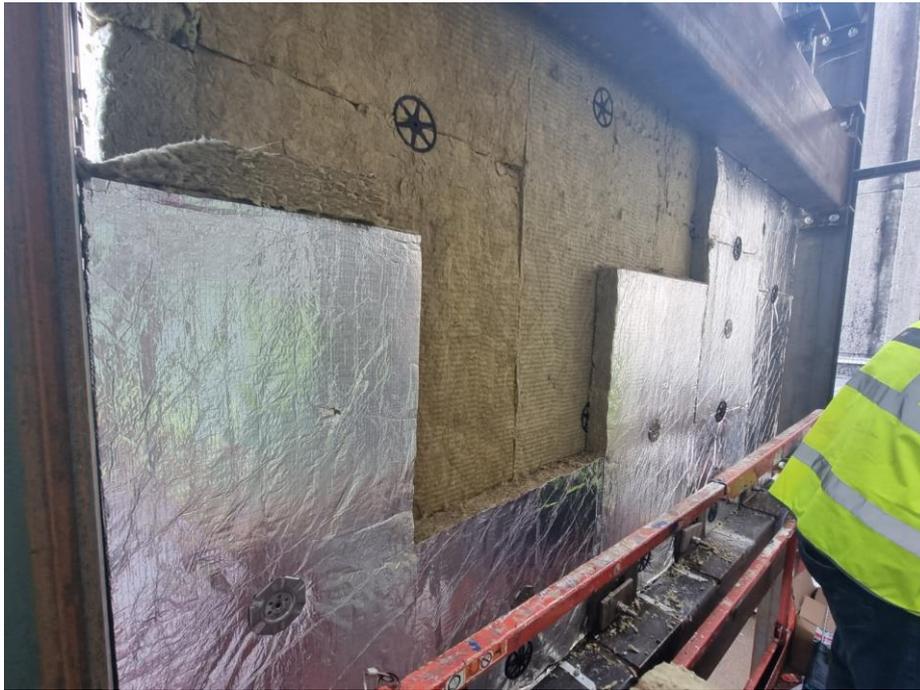
Figure 31 Front face of insulation

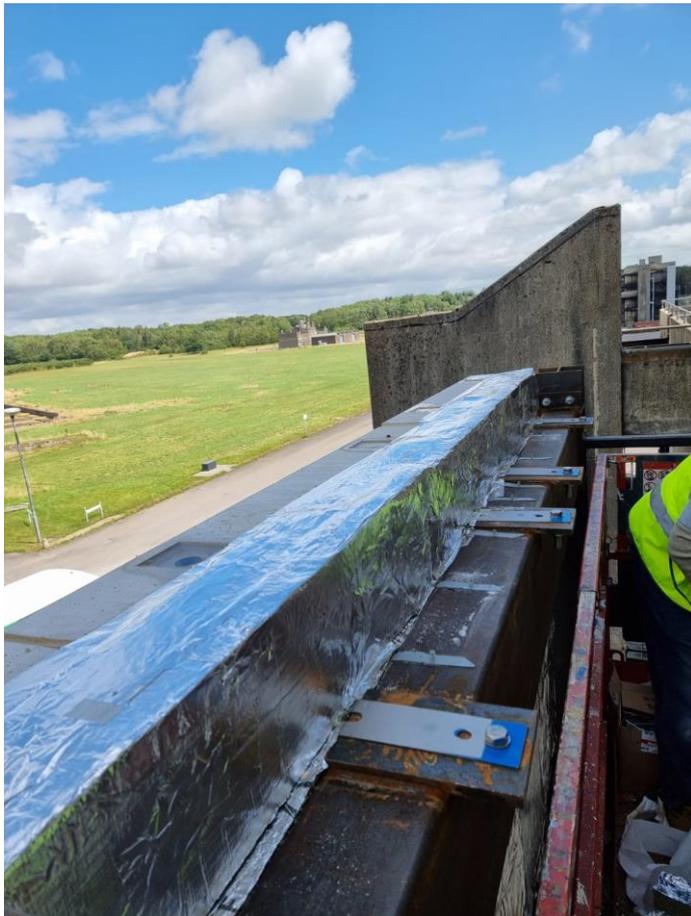
Figure 32 Detail of top of façade

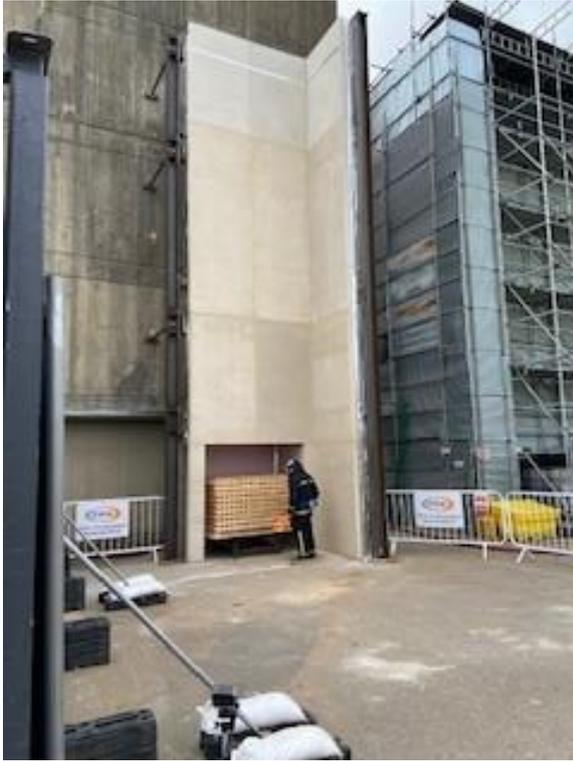
Figure 33 Full façade prior to ignition of crib

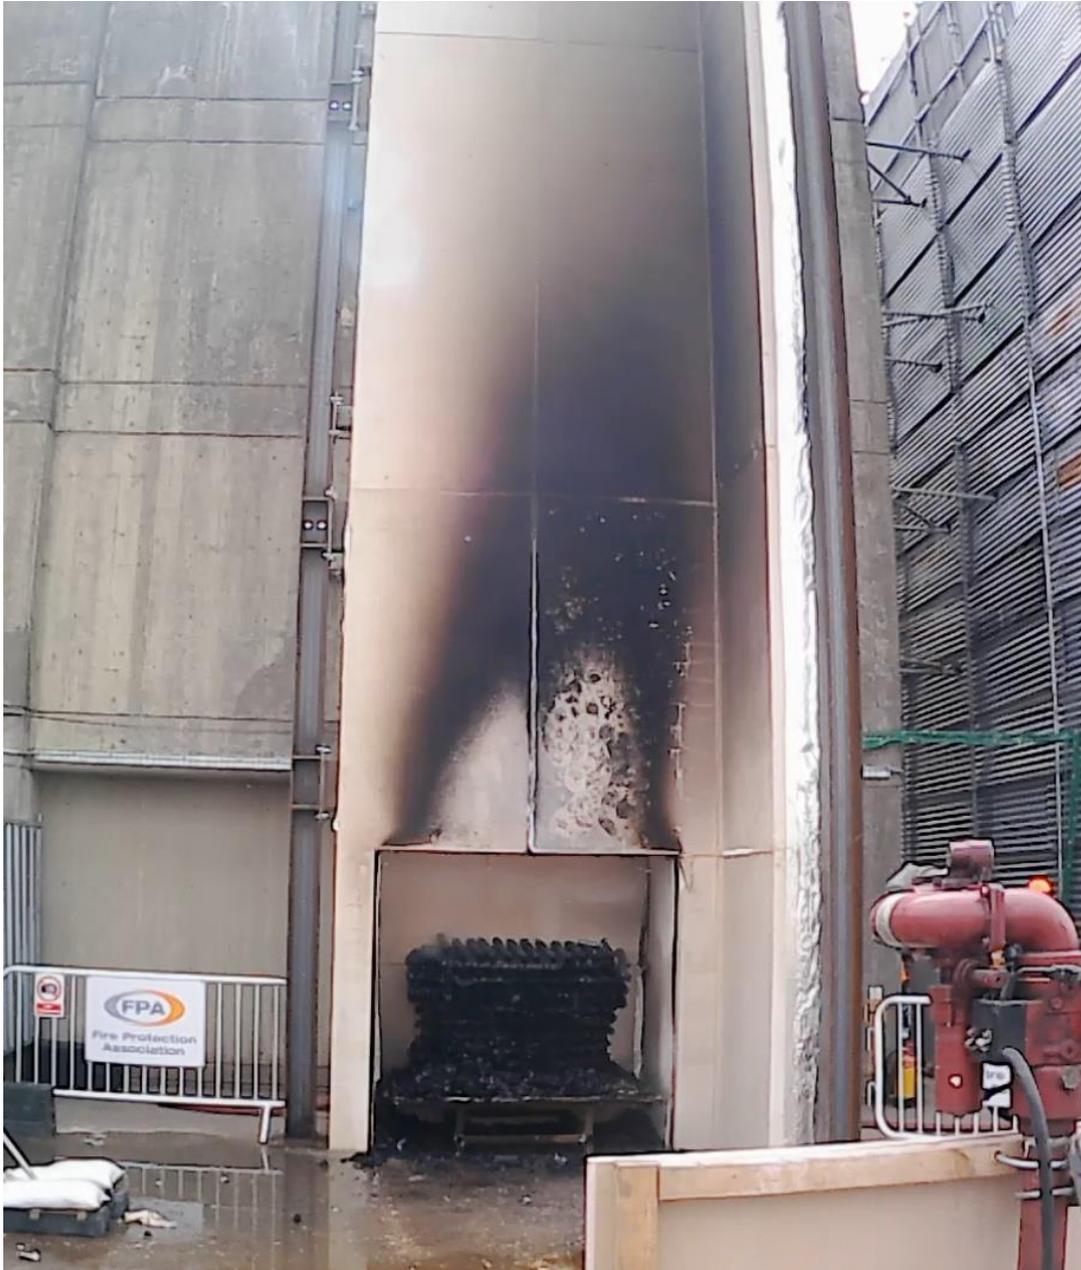
Figure 34 – Full façade post test

The system appeared to be structurally intact post-test with some spalling from the concrete façade. No further information on the mechanical performance is available.
